ROAD BAY JETTY INSPECTION

**GOVERNMENT OF THE BRITISH OVERSEAS
TERRITORY OF ANGUILLA**

65 Wks Gp RE
65/04_05_08
30 Jul 14

By
509 STRE (Port Infra)
65 Wks Gp RE

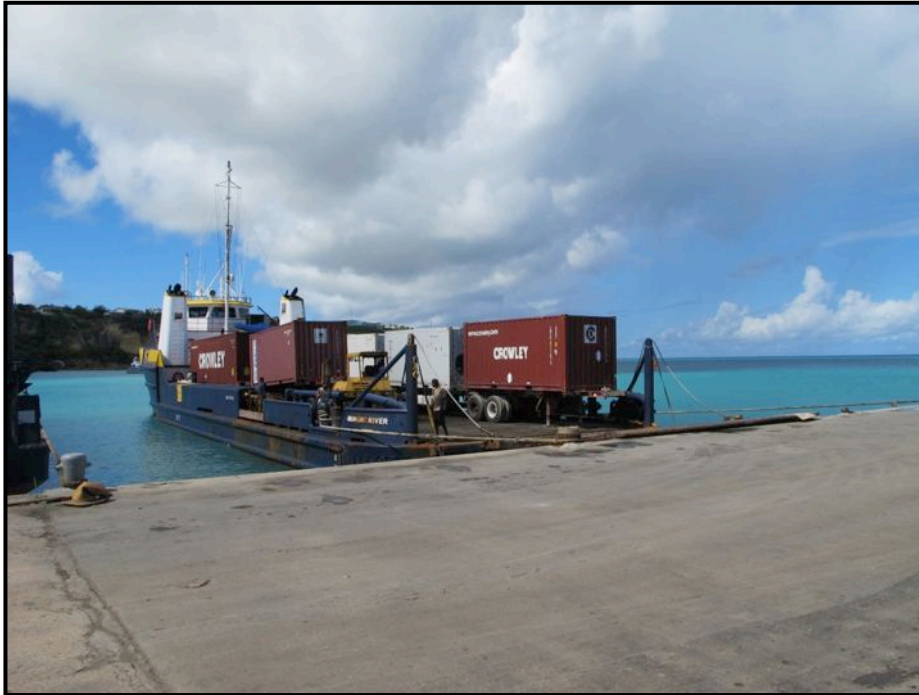
35. The main structure has experienced significant damage from collision with ships and from it being used inappropriately as a RO-RO jetty. The majority of the ships that berthed on the jetty during the site visit were RO-RO vessels with a high percentage of them berthing side on to the jetty. Any impact from a vessel when berthed in this manner could cause a fatal structural failure of the jetty and render it unusable.

Fig 3 - RO-RO Ship Berthed 'Side-On' to the Jetty

36. To continue to use the jetty at risk, the following operational restrictions need to be implemented:

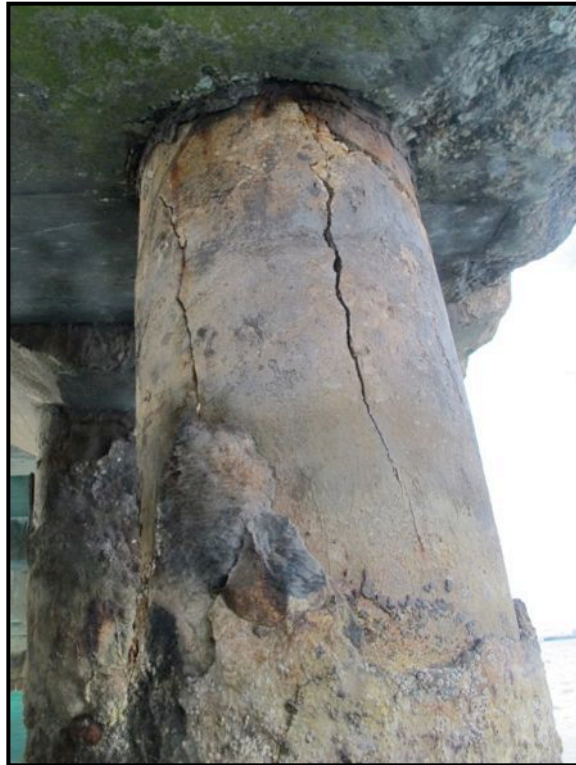
Figure F1 – Typical Damage to Pile

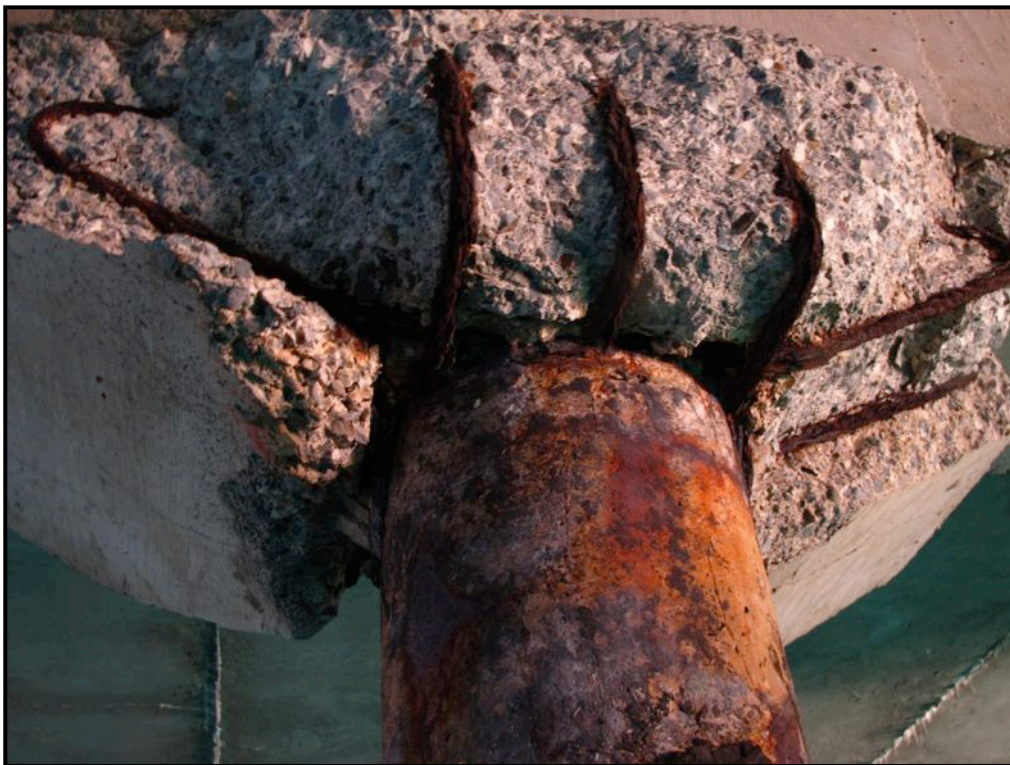
Figure F2 – Typical Pile Cap Corrosion

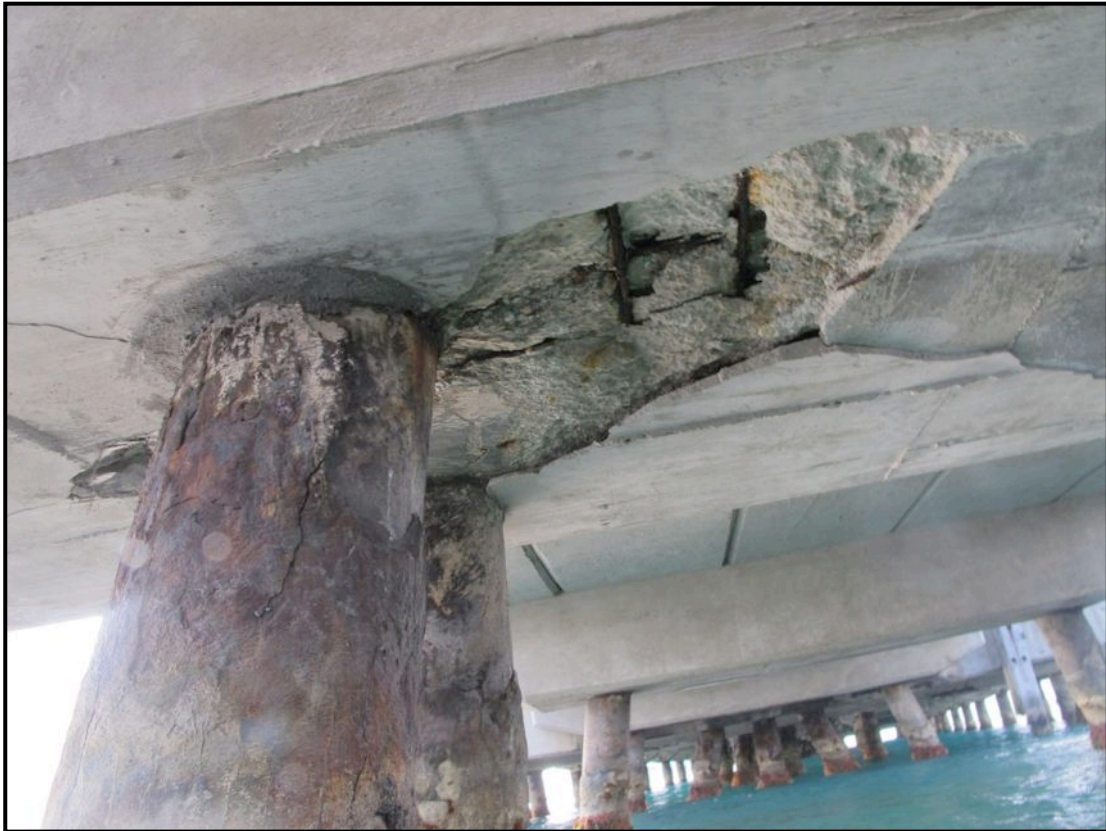
Figure F3 – Jetty Approach Bent Soffit Delamination & Corrosion of Raking Piles

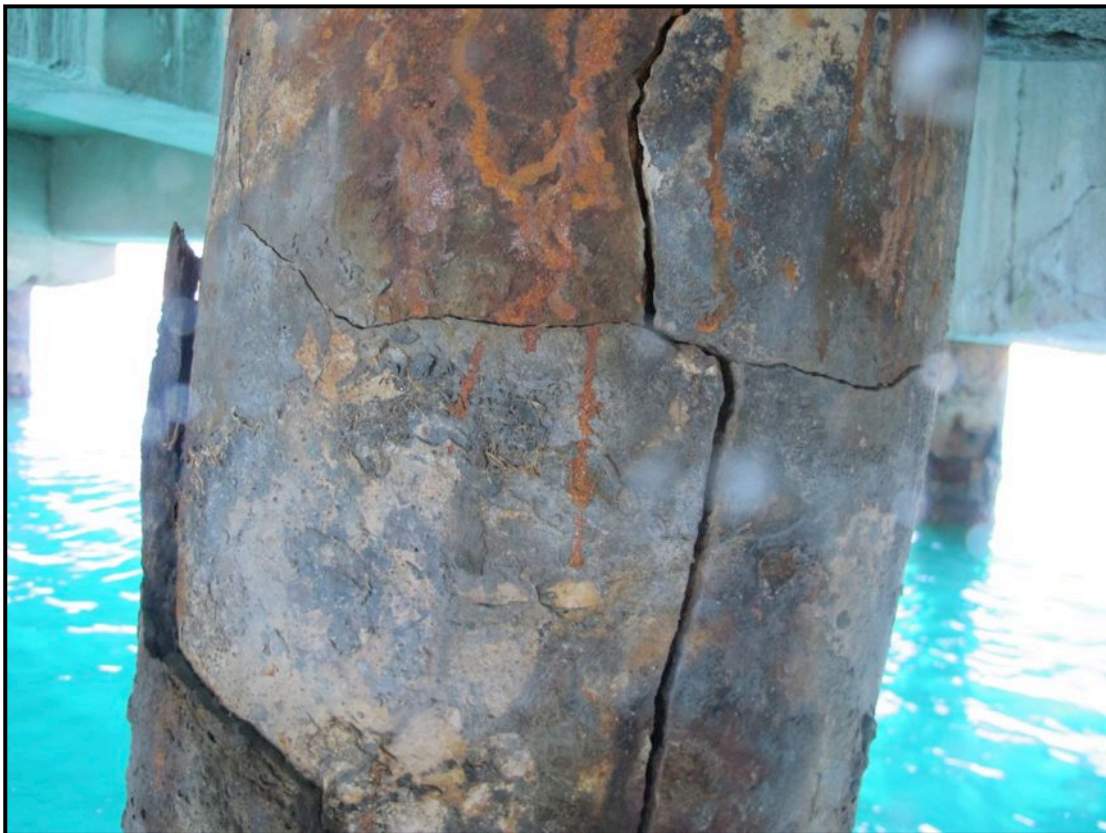
Figure F4 – Severe Damage to Failed Pile

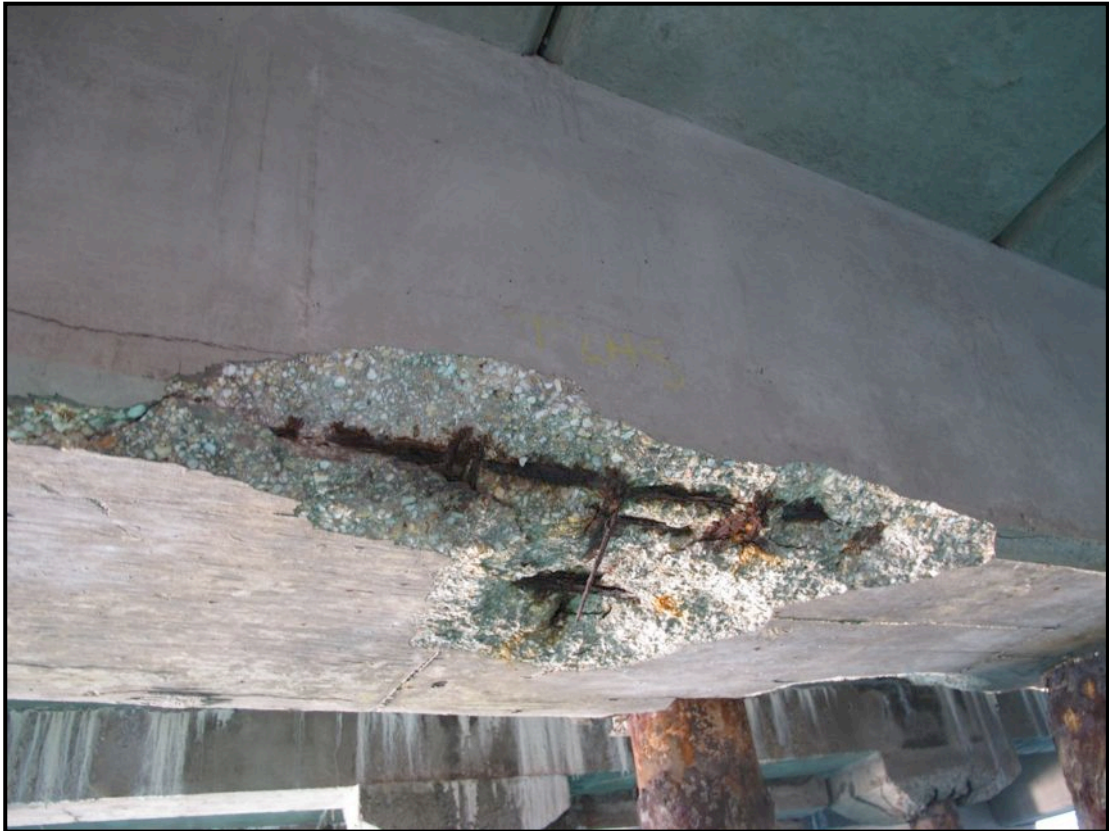
Figure F5 – Underside to Bent showing Spalling & corrosion to Rebar

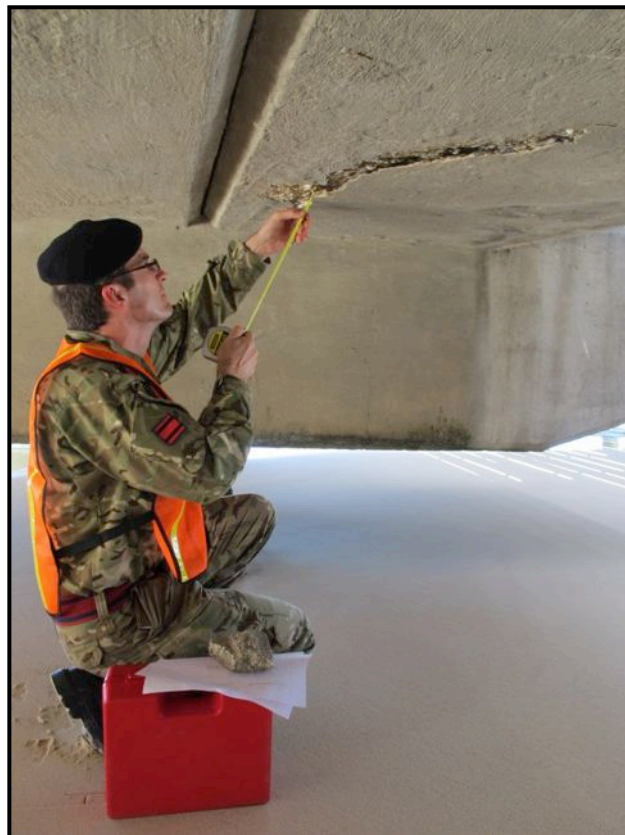
Figure F6 – Underside to Jetty Approach showing Slab Delamination

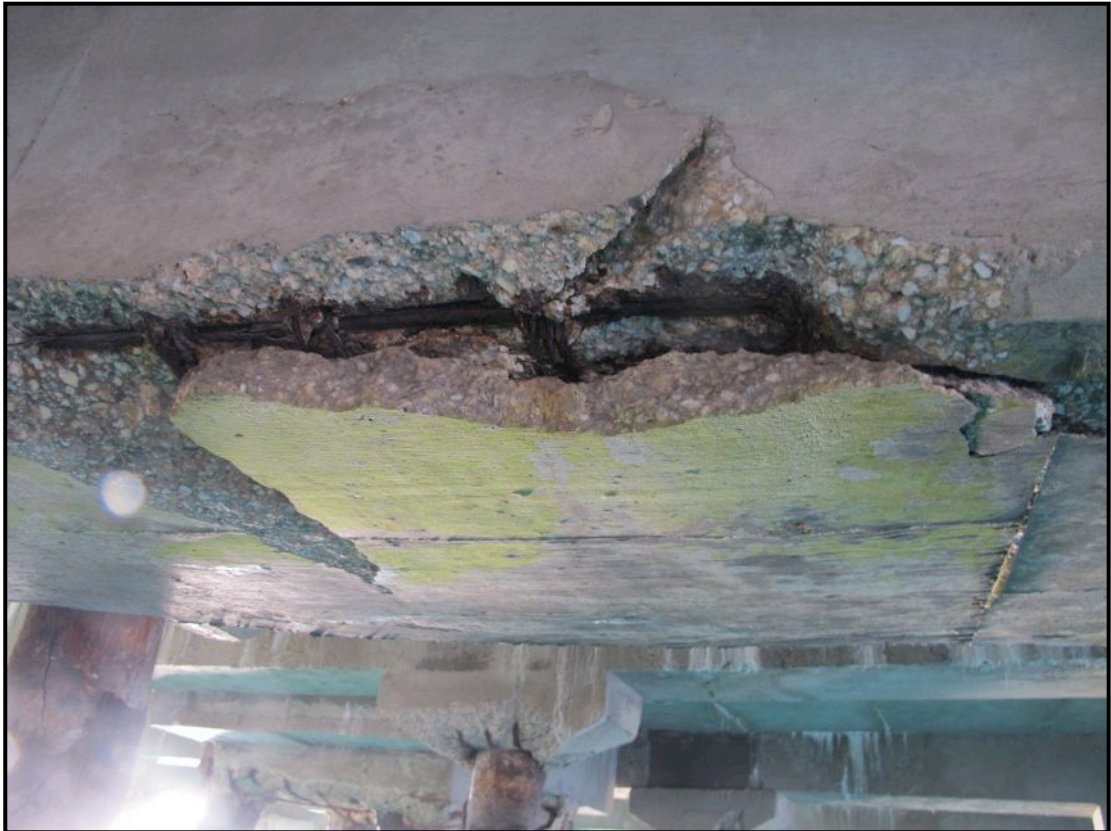
Figure F7 – Underside to Bent Showing Delamination and Rebar Corrosion

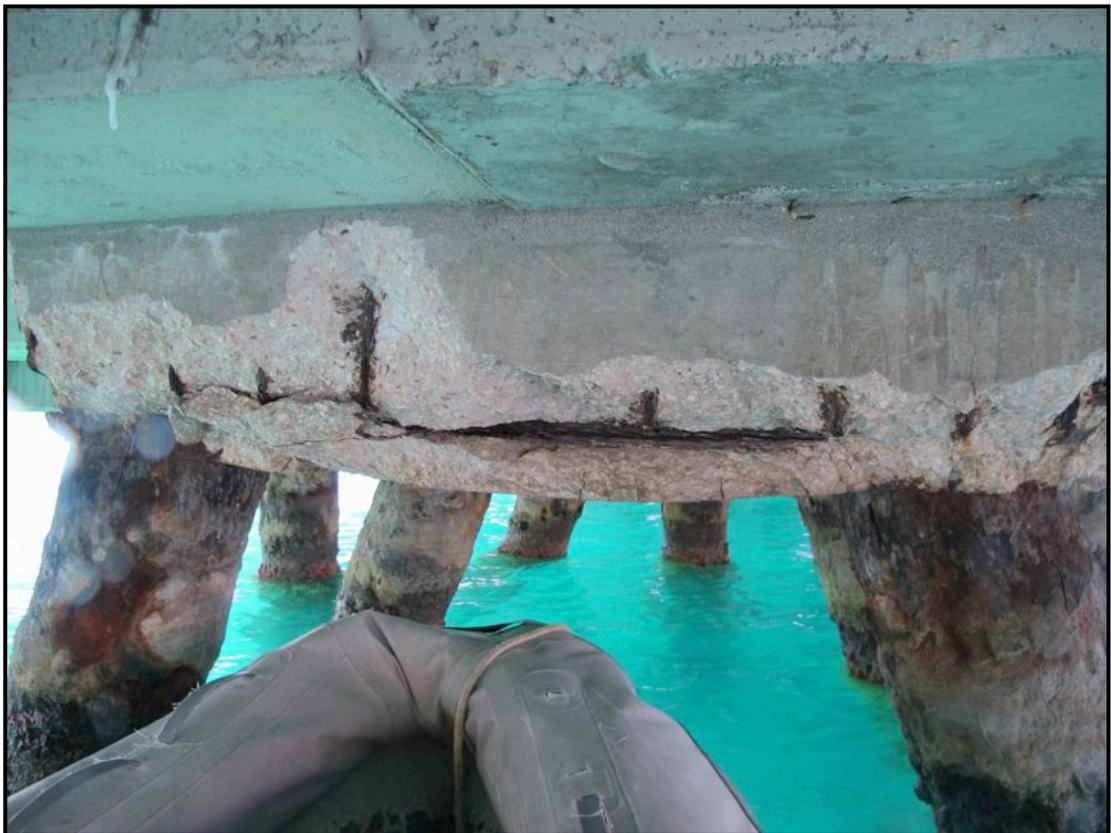
Figure F8 – Main Jetty Spalling to Concrete around Raking Piles Showing Corrosion to Steel

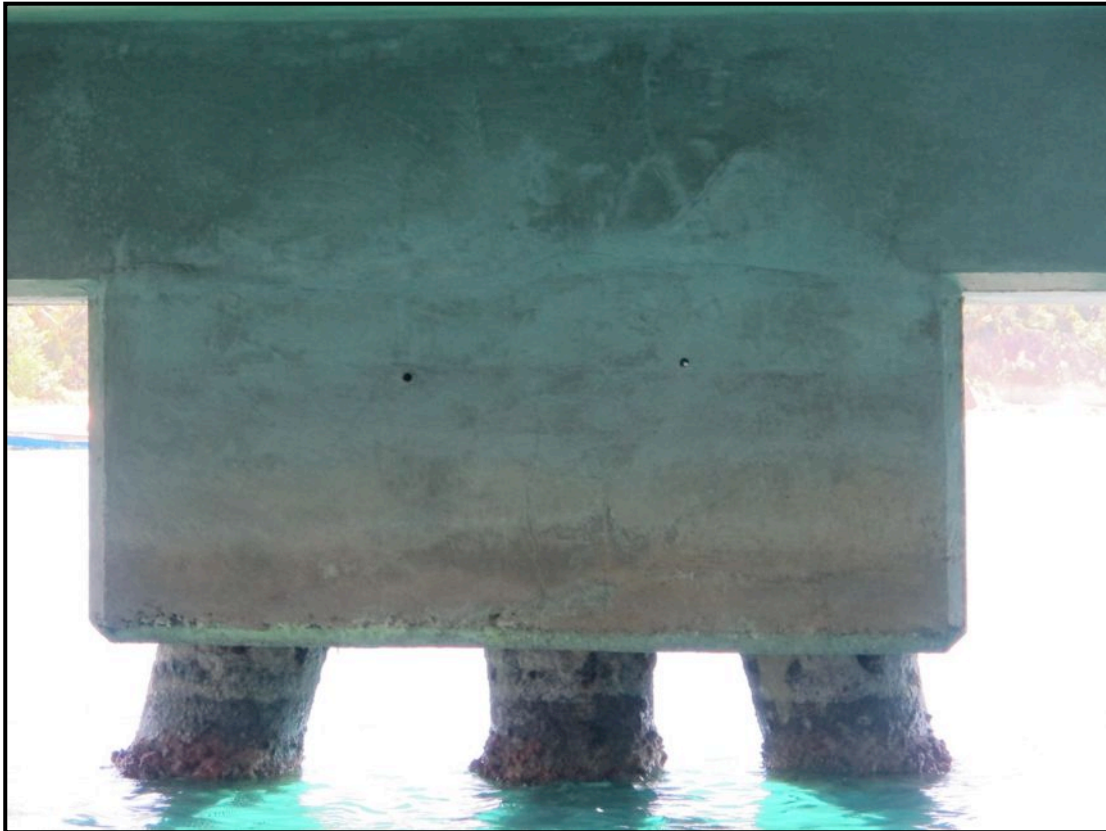
Figure F9 – Underside Repair Extension to Pile Cap

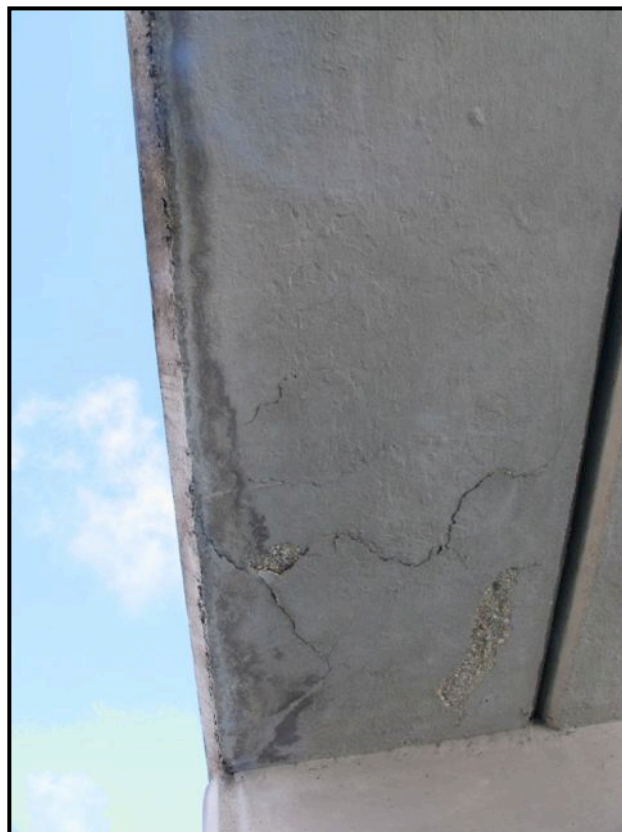
Figure F10 – Cracking to Main Jetty Approach Slab

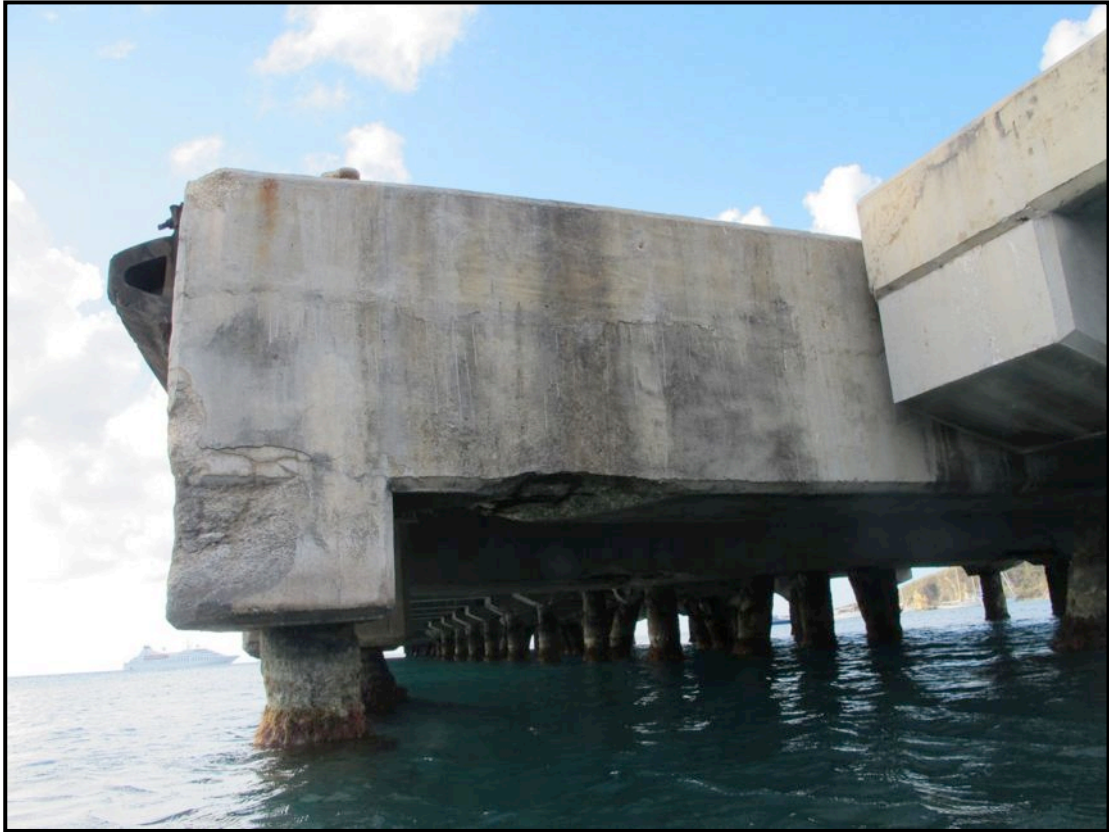
Figure F11 – Main Jetty Impact Damage

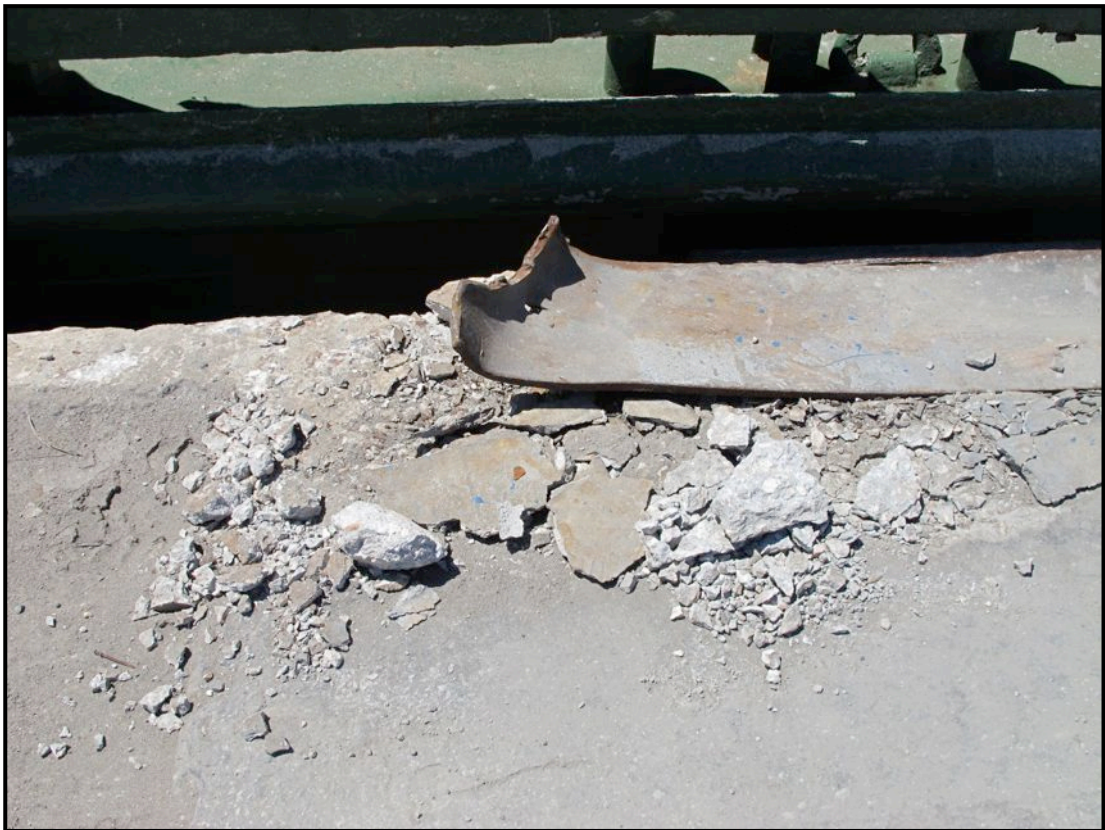
Figure F12 – Main Jetty Impact Damage to Edge Steel

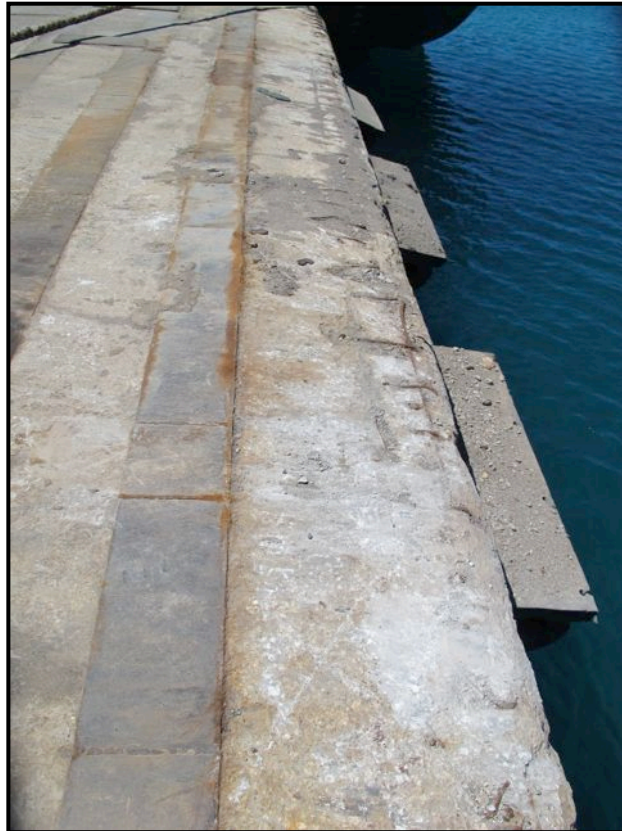
Figure F13 – Abrasion Damage to Main Jetty End

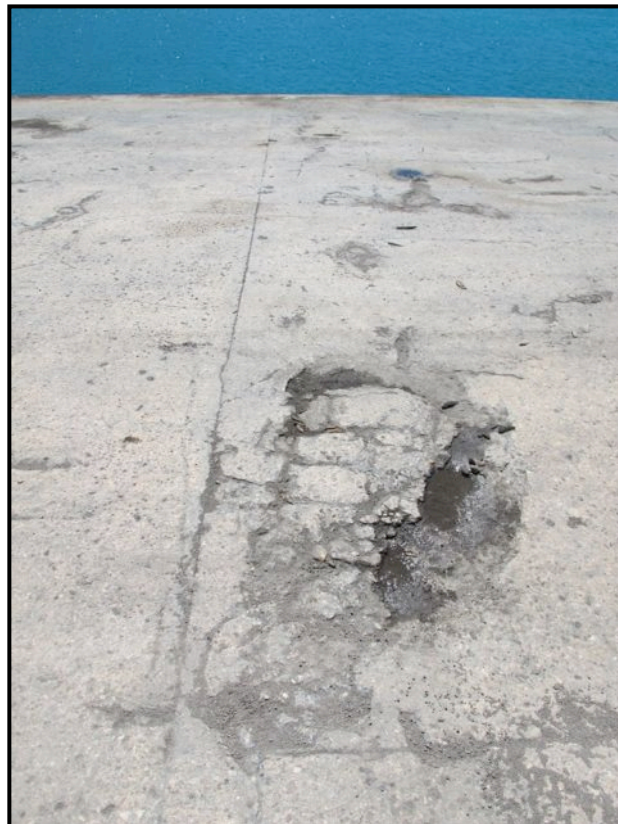
Figure F14 – Main Jetty Surface Degradation

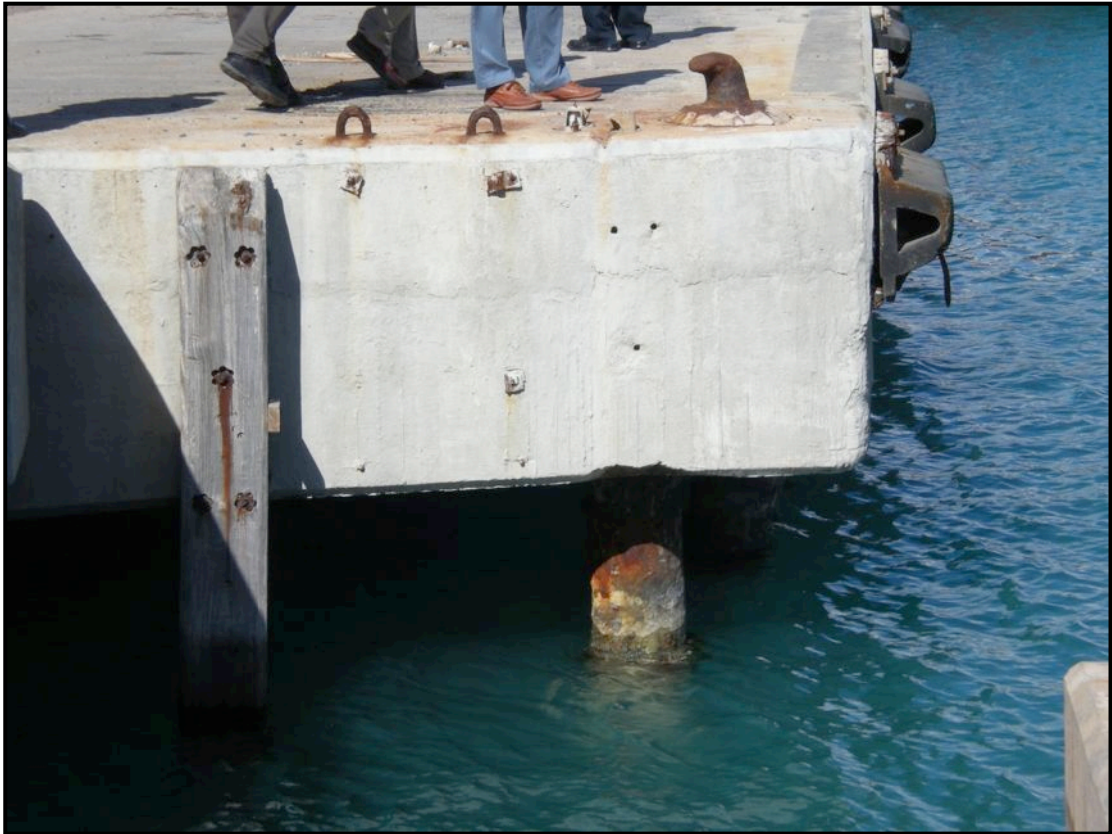
Figure F15 – Missing Ladder & Mooring Bollard Type 1

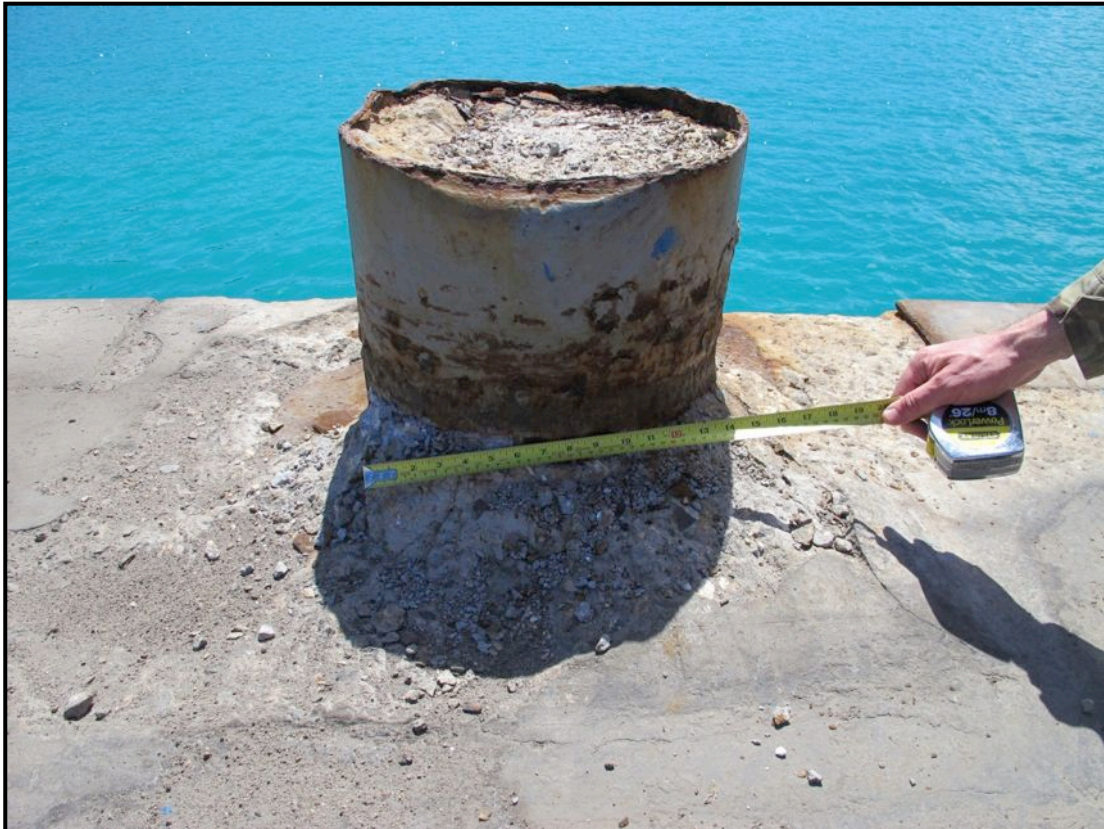
Figure F17 – Mooring Bollard Type 3

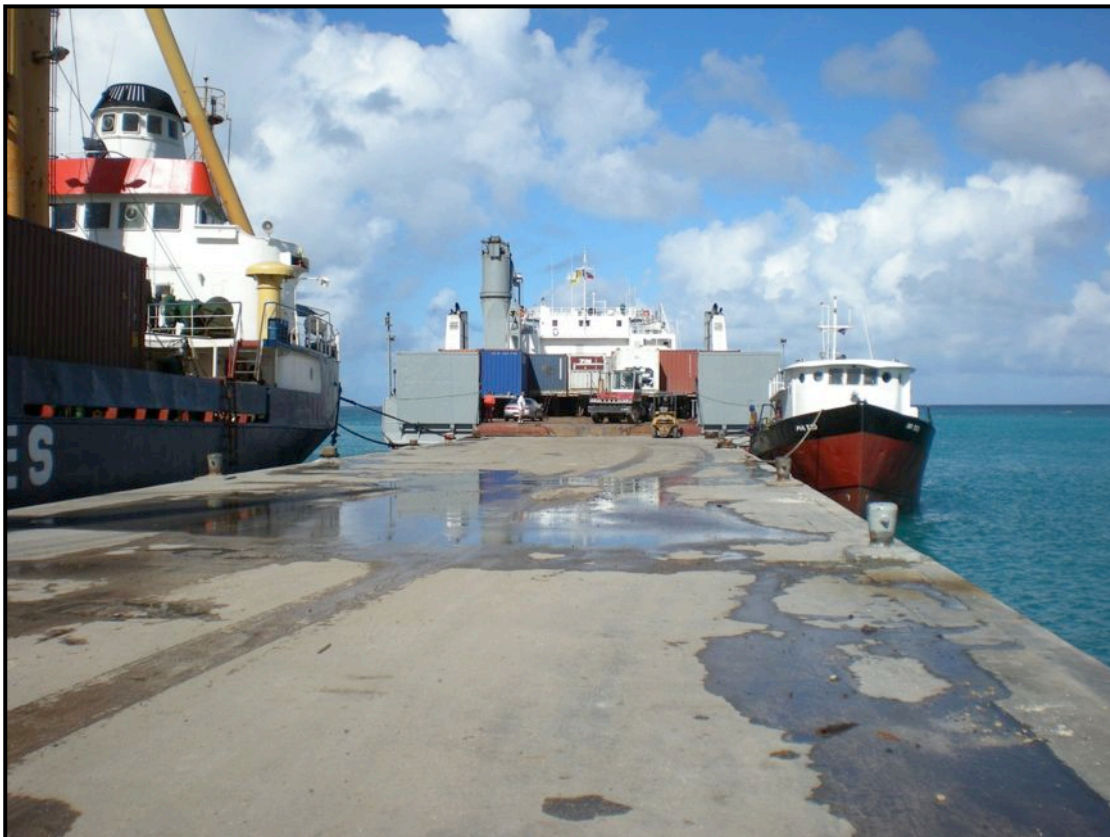
Figure F18 – Worn Surface of Jetty
