ROAD BAY JETTY INSPECTION

**GOVERNMENT OF THE BRITISH OVERSEAS
TERRITORY OF ANGUILLA**

65 Wks Gp RE
65/04_05_08
30 Jul 14

By
509 STRE (Port Infra)
65 Wks Gp RE

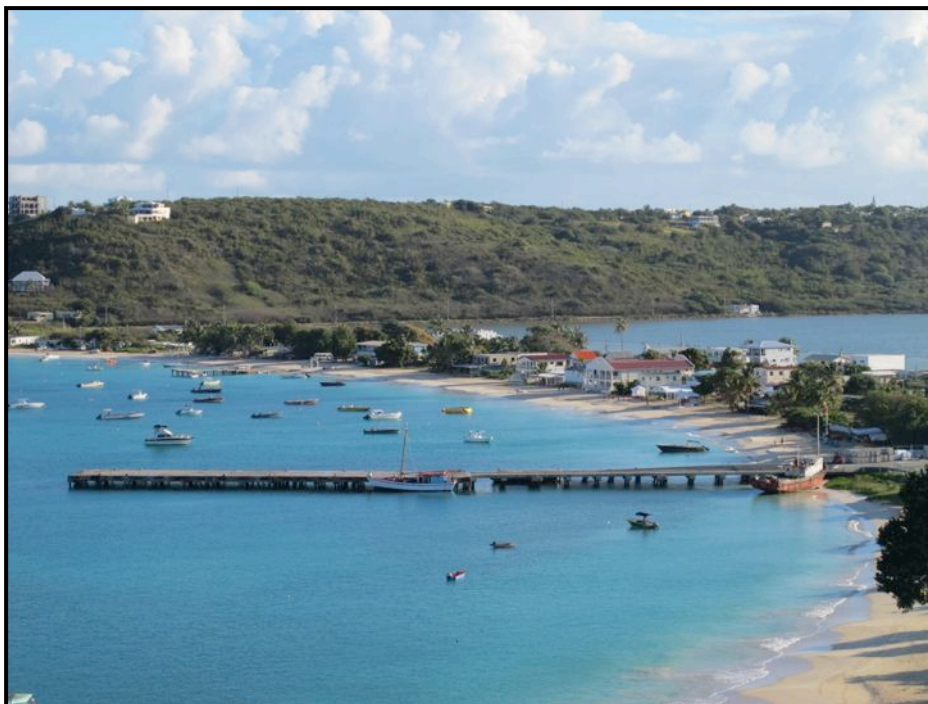
Fig 1 - Road Bay Jetty, Anguilla

15. From the time of the 1993 structural survey up to 2001 the cracks in the pile caps got worse and further serious damage occurred to a number of other piles from vessels and barges moored alongside.
